Lewiston-Porter Central School District 2020 Building Condition Survey

**TRAUTMAN
ASSOCIATES**

2020 Building Condition Survey

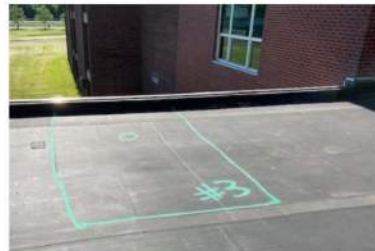
HS, Wet Area #3 (66 Sq. Ft.) with puncture circled within wet area.

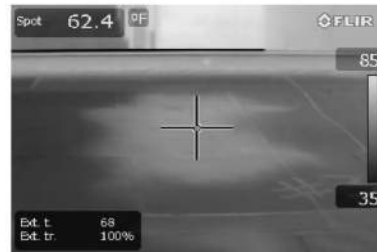
HS, Thermal image of Wet Area #3.

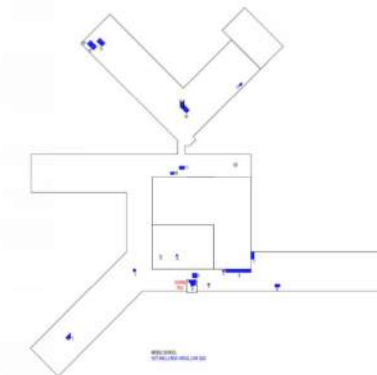
- Middle School
 - 18 wet insulation areas located.
 - Total of 994 square feet wet insulation.
 - Punctures noted in wet areas 4, 12, 13, 16, 17.

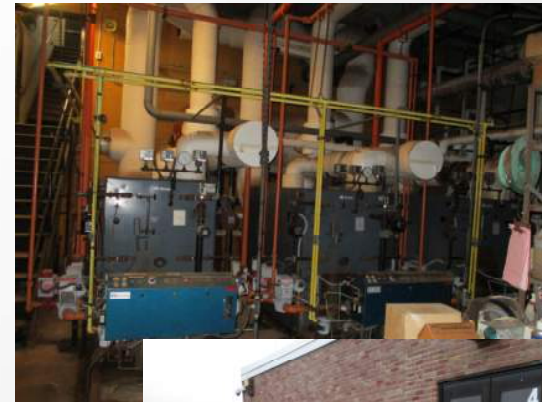
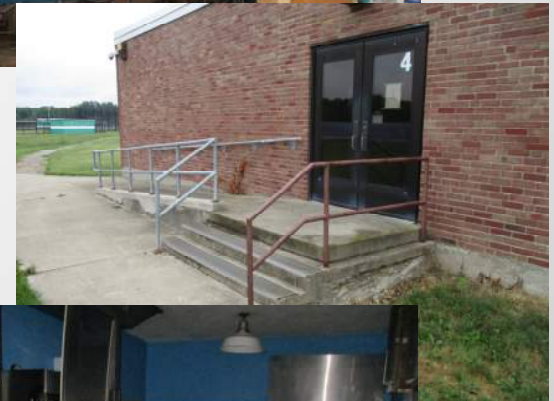
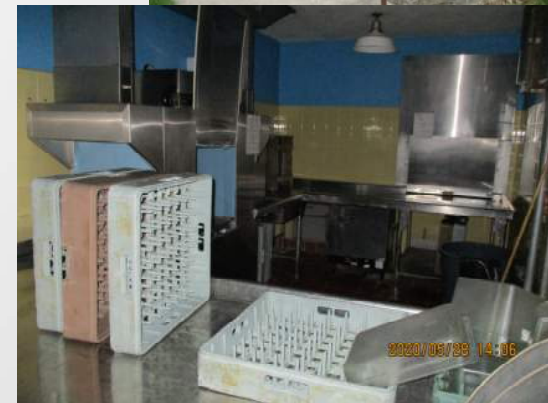
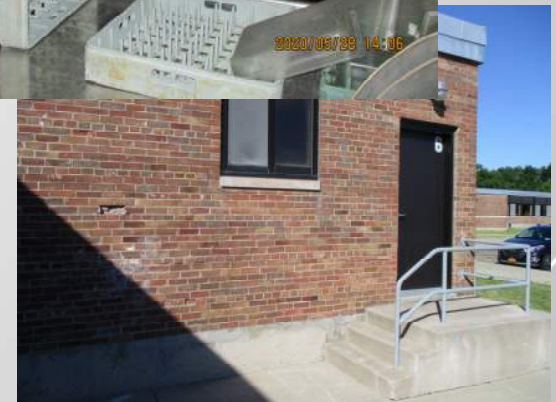
Middle School

- Parking Lot, Roadways, and Sidewalk Reconstruction - \$792k
- Exterior and Interior Door Replacements - \$805k
- Window Replacements – \$1.84m
- Boiler and Steam Piping Replacement - \$363k
- Unit Ventilator & RTU Replacement - \$2.44m
- Mechanical Cooling/AC System - \$185k
- Steam Piping Replacement - \$1.65m
- HVAC Control Upgrades - \$660k
- Kitchen Upgrades - \$1.06m
- Crawlspace Ventilation - \$80k

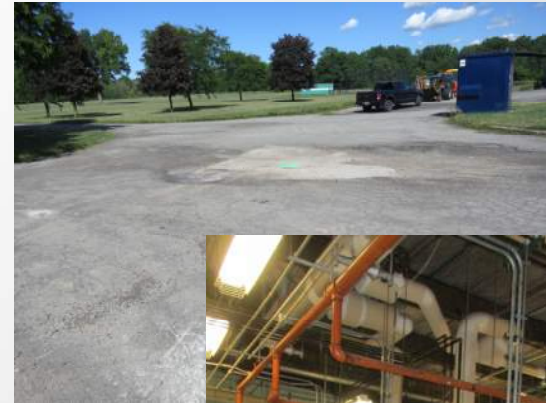
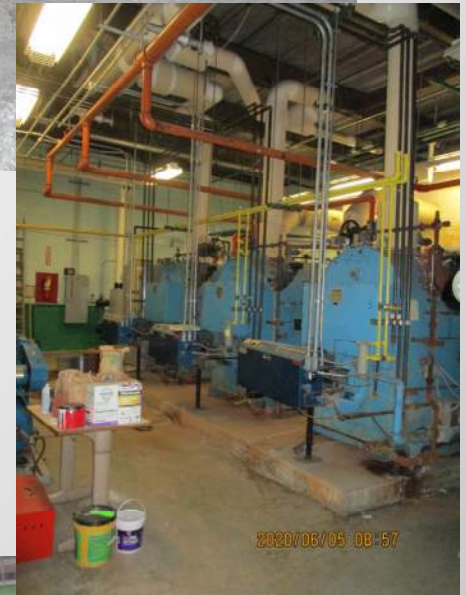
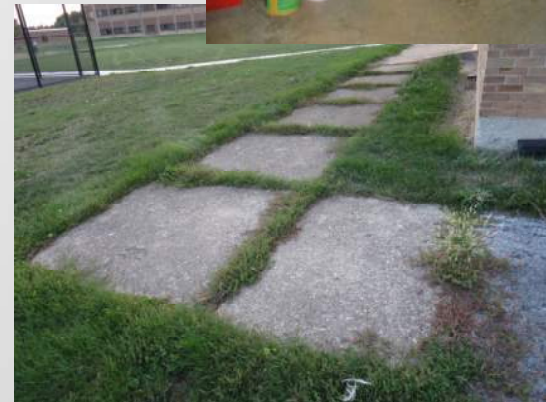
Intermediate Education Center

- Parking Lot and Sidewalk Reconstruction - \$1.75m
- Interior Door Replacements - \$354k
- Boiler Replacement - \$330k
- AHU & RTU Replacement - \$528k
- Split System Replacement - \$66k
- Steam Condensate Piping Replacement - \$1.45m
- Radiator and Convactor Replacement - \$528k
- HVAC Control Upgrades - \$488k
- Phone & PA System Upgrade - \$179k
- Boys and Girls Locker Rooms - \$1.58m
- Kitchen Upgrades - \$1.06m
- Crawlspace Ventilation - \$80k

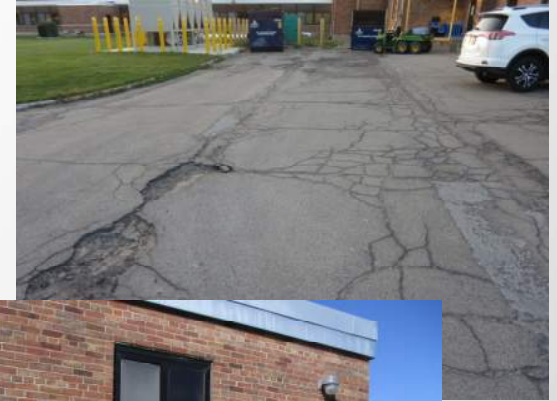
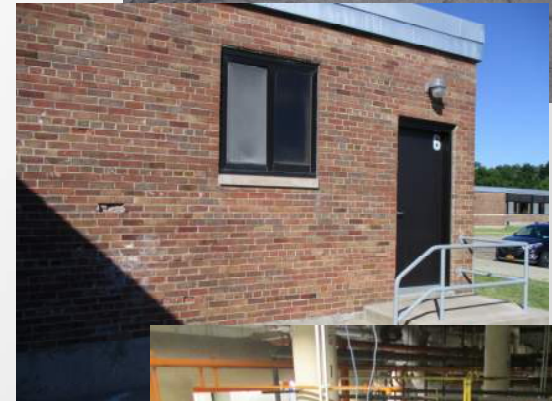
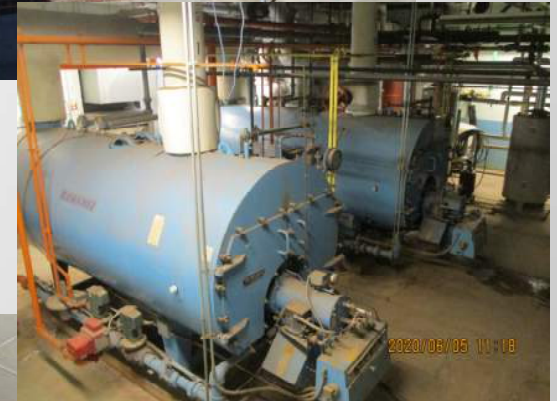
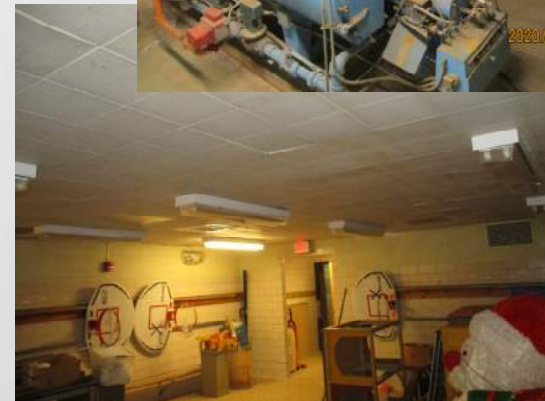
Primary Education Center

- Parking Lot, Roadways, and Sidewalk Reconstruction - \$528k
- Masonry Wall and Foundation Repairs - \$607k
- Window Replacements - \$1.76m
- Interior Door Replacements - \$449k
- Boiler Replacement - \$264k
- Water and Sanitary Piping Replacements - \$290k
- Phone & PA System Upgrade - \$179k
- Boys and Girls Locker Rooms - \$868k
- Kitchen Upgrades - \$924k
- Crawlspace Ventilation - \$132k

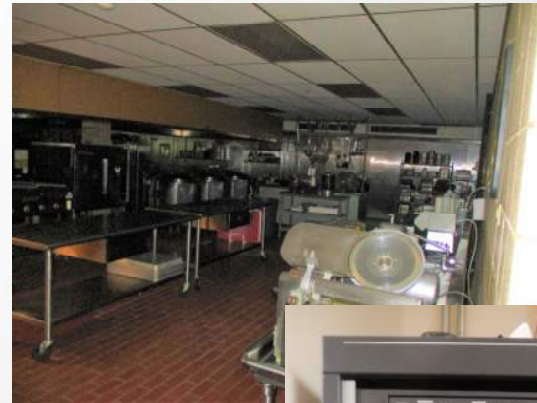
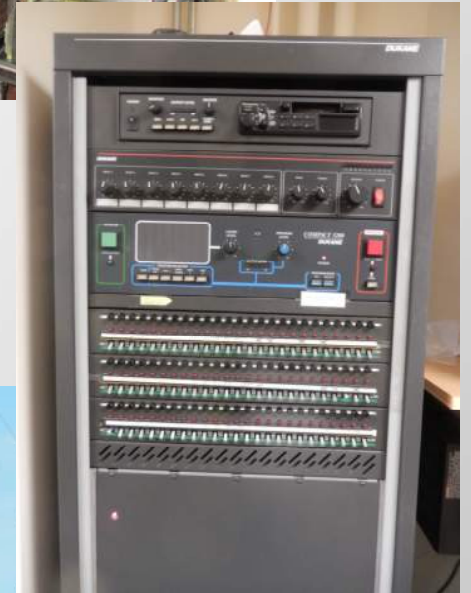
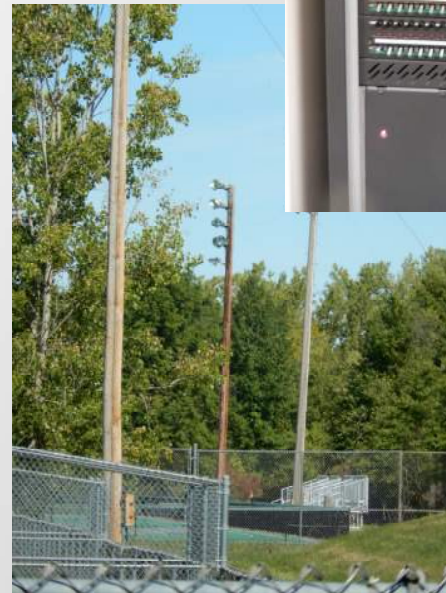
High School

- Athletic Field Lighting Replacement - \$1.45m
- Parking Lot, Roadways, and Sidewalk Reconstruction - \$3.07m
- Synthetic Turf Replacement - \$750k
- Masonry Wall Repairs - \$430k
- VCT Replacement in A-Wing - \$231k
- HC Access to Seating in Pool - \$330k
- Heat Exchange Replacement - \$132k
- Plumbing Fixture Replacements - \$495k
- Kitchen Upgrades - \$1.06m
- Crawlspace Ventilation - \$158k

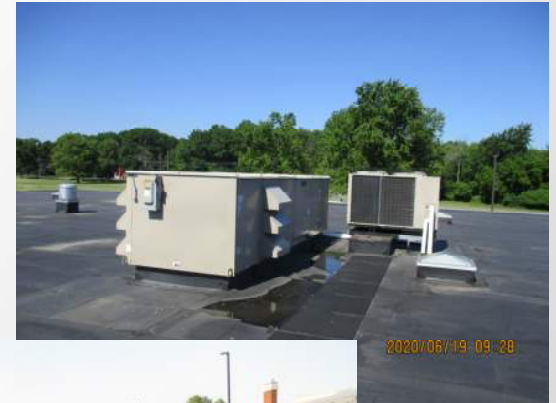
Community Resource Center

- Parking Lot & Roadways Reconstruction - \$726k
- Gym AHU & Exhaust Fan Replacement - \$158k
- Cooling / AC - \$142k
- HVAC Control Upgrades - \$66k
- Analog Phone System Upgrade - \$26k

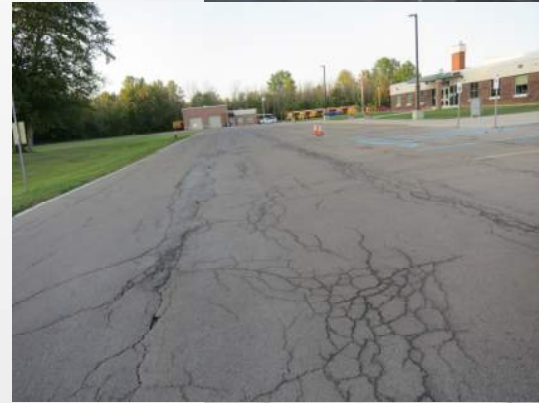
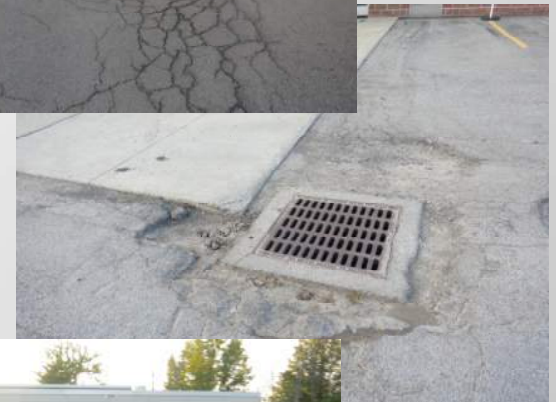
Maintenance Building

- Parking Lot & Roadways Reconstruction - \$475k
